THE COMMUNICATOR SURREY AMATEUR RADIO CLUB

Aerial Adventures

With Gary Skett, VE7AS

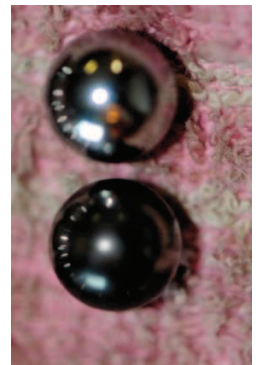
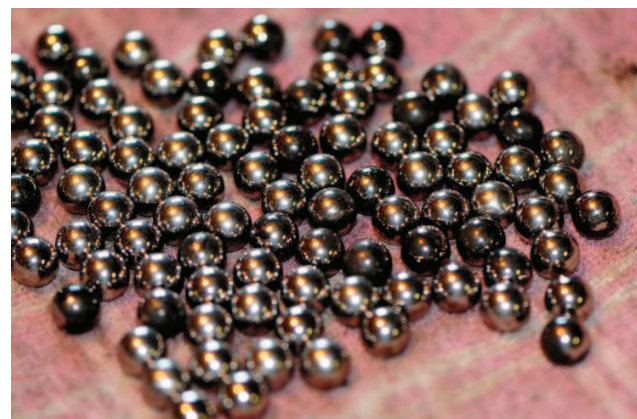
Stain Discoloration

Caused by breakdown of lubricant. If stain can be removed with solvent or light polish, a complete cleaning and repacking is all that is probably required to put assembly back in service 60% of the bearings in the rotor will need replacing. (See the greyish or black bearings among the shiny ones?)

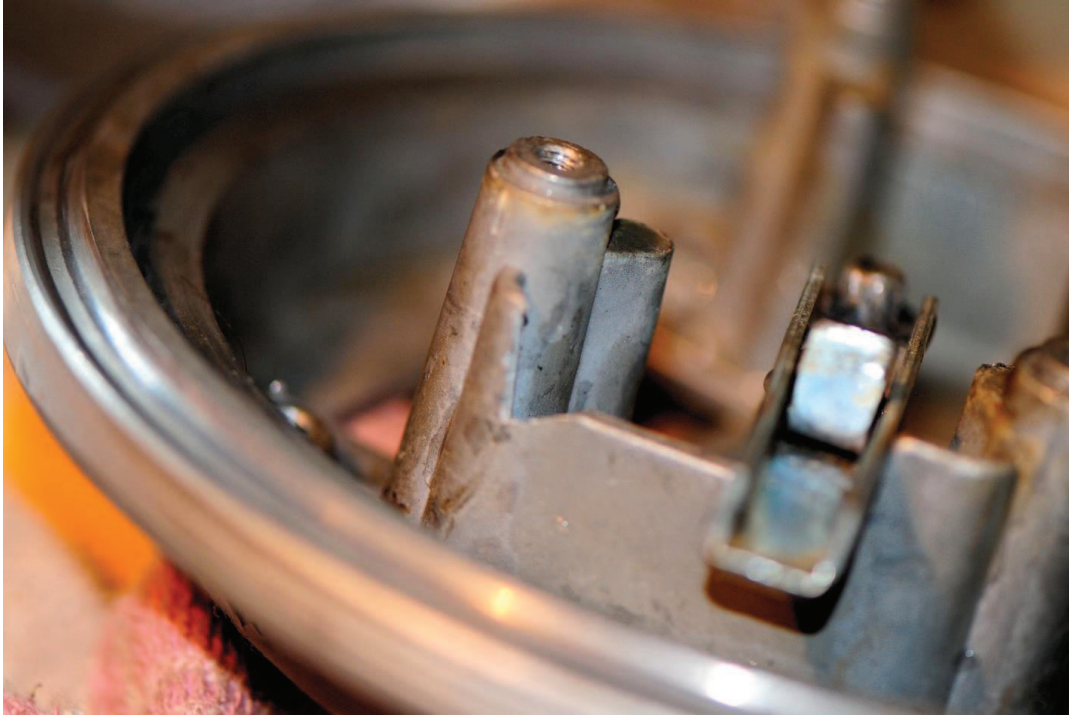
Here you can see the broken chip out of the left stop. This was due to the absence of a brake in this model and the fact that the load was too heavy for the rotor. Wind load would have done this damage...and the switch that sits by this stop was also bent out of shape.

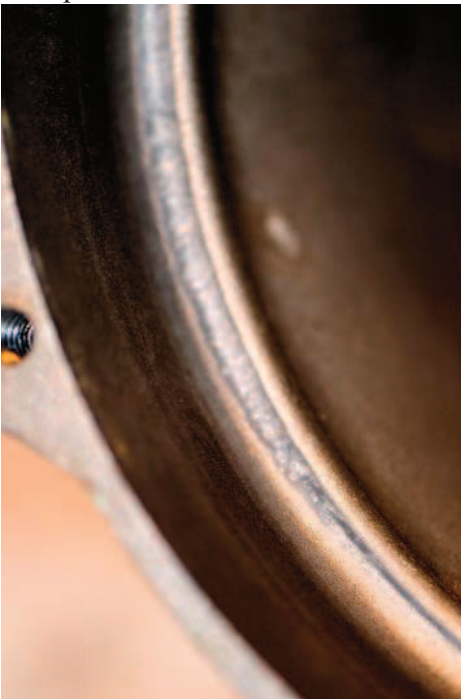
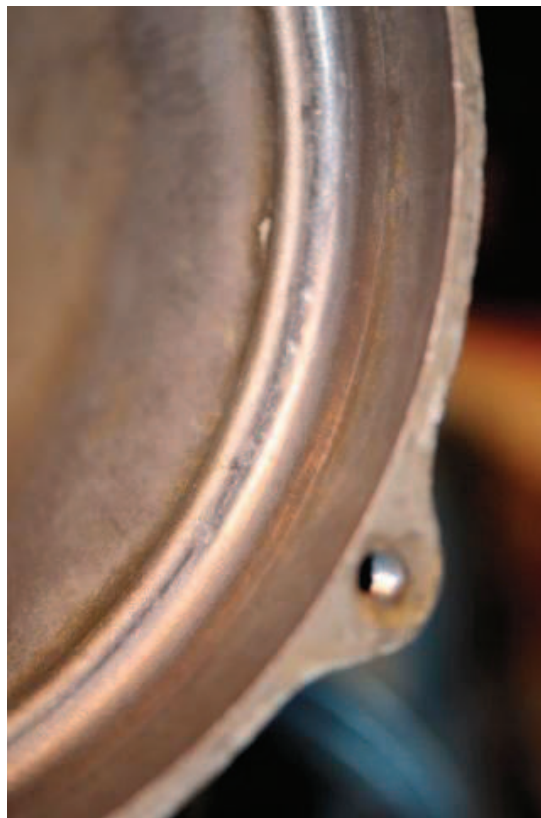
The photos below show the bell housing. Note the damage along the bearing runner. This indicates the load was unevenly placed on the rotor as either the thrust bearing was not properly adjusted, or more likely the whole load of the mast and antenna was put on the rotor....unevenly – not a “balanced” weight-bearing load.

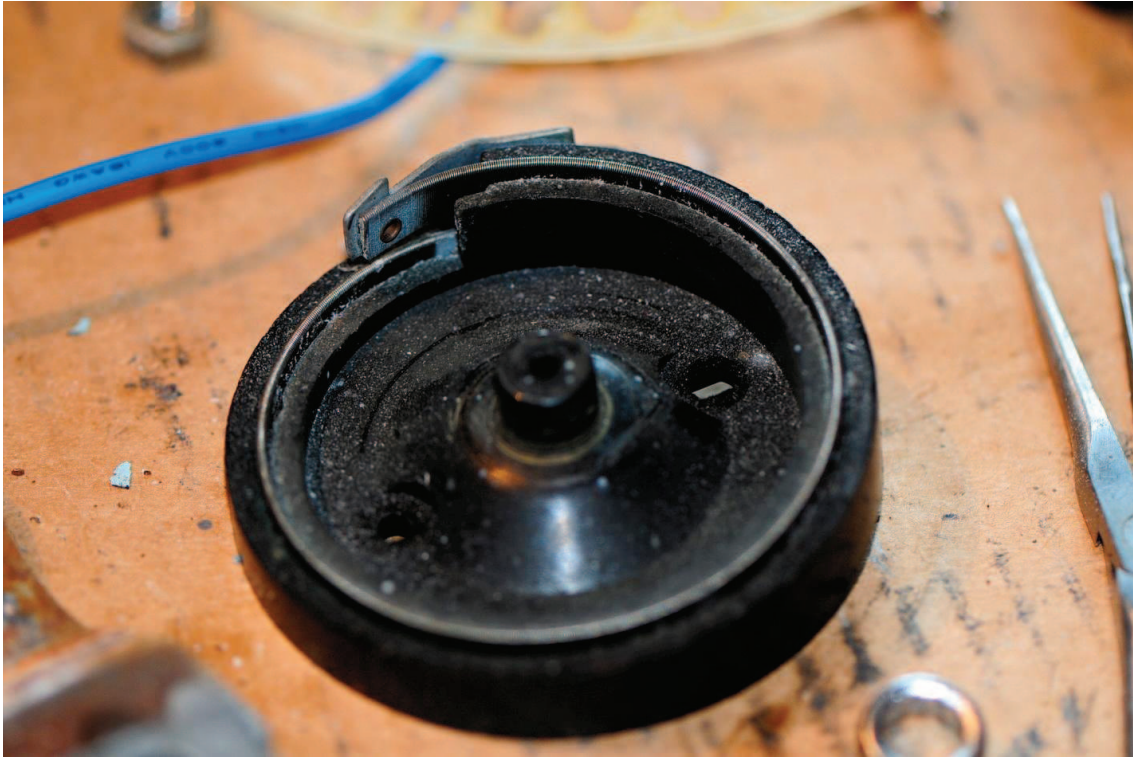
Here we can see the meter pot...missing the entire arm! Where did it go? I could not find any remains inside!

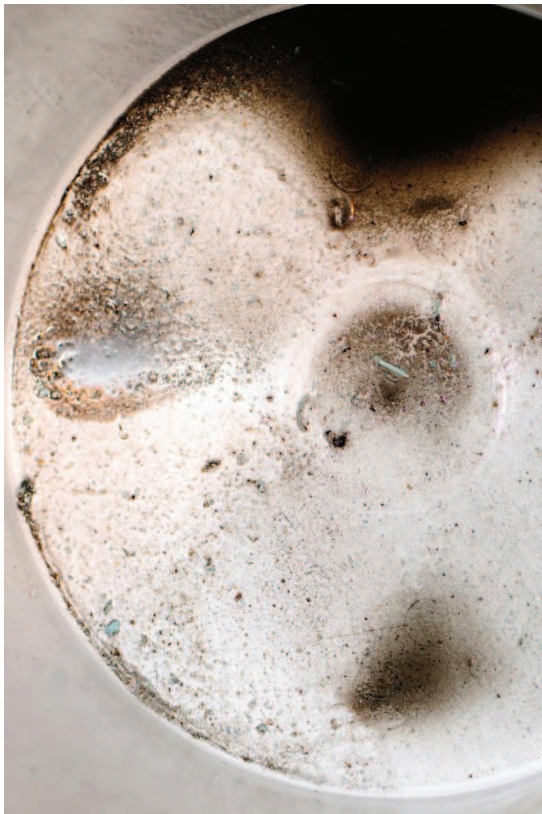
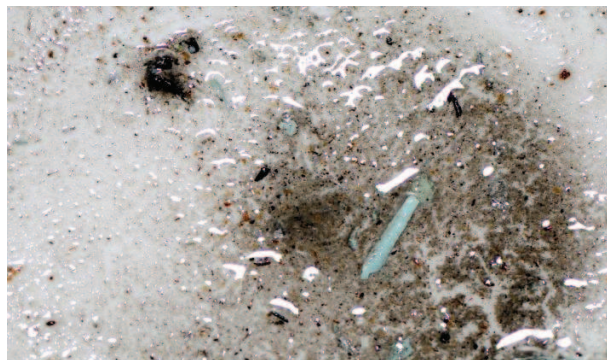
At the bottom of my Varsol tub, when all the 3 to 4 varieties of grease where removed from the INSIDE of the housing...this is what was mixed in with the grease....dirt, metal bits and sand....maybe the pot arm is in there somewhere?

This pail was new and perfectly clean before I put the rotor parts and bearings in it!!

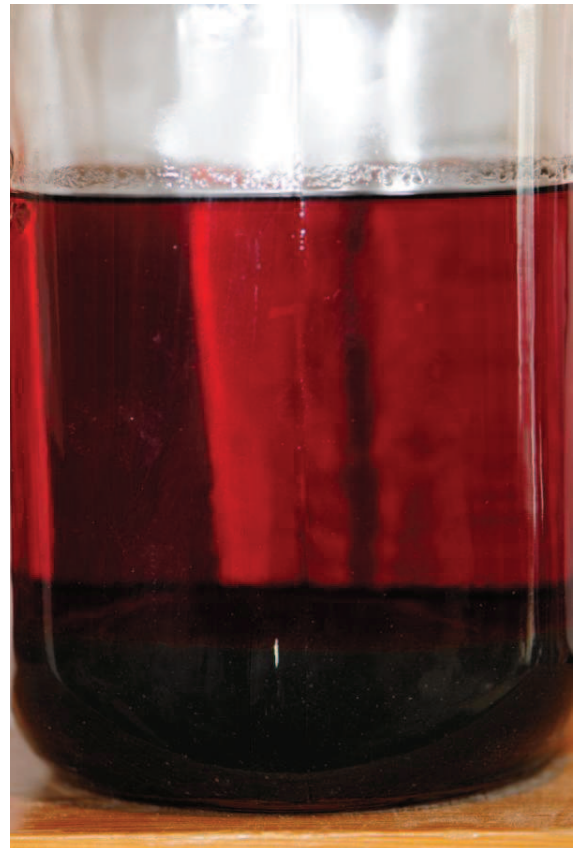
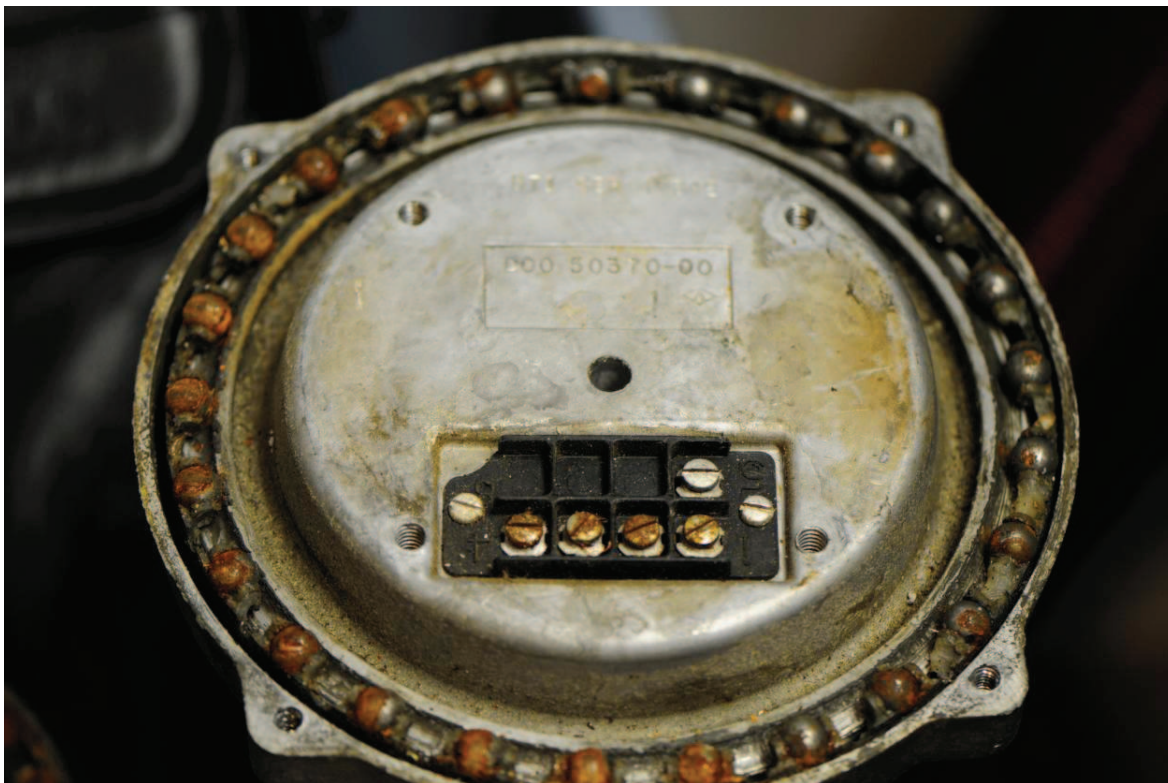
The photo to the right is a glass jar filled with Varsol. The 1 inch of black sludge at the bottom is what came off of a Ham II gear set and about 50 ball bearings I soaked overnight. That material is from bearing wear, dirt and metal bits from a decade of neglect. The “If it works, don’t touch it” philosophy from this Ham worked fine, until it stopped dead just 10 years into service. Had he taken care of it, he would have 30 more years of life....now I do! The grease he used solidified, allowed dirt and water ingress and it seized after a season or two of little or no use. He also “sealed” the terminal block with silicone sealant...and they rusted...the sealant kept the moisture inside nicely....Instead if using silicone based compounds, try spraying your terminal block and antenna/element connections with a UV resistant lacquer or polymer-based coatings.

No, grease doesn't keep water out of the bearing track! See the globs of solidified grease on the right?

How much grease to use you ask? A thimble full on the bearing tracks and gear teeth – that’s total – not a thimble full for each friction point. And that is after you have cleaned out the old grease and cleaned the inside...don’t just add new grease over old grease....it’s like adding new oil to dirty oil in your car...you replace that every 5000 Km, you need to clean out and replace the grease inside your rotor every 5-8 years, depending on your duty cycle.

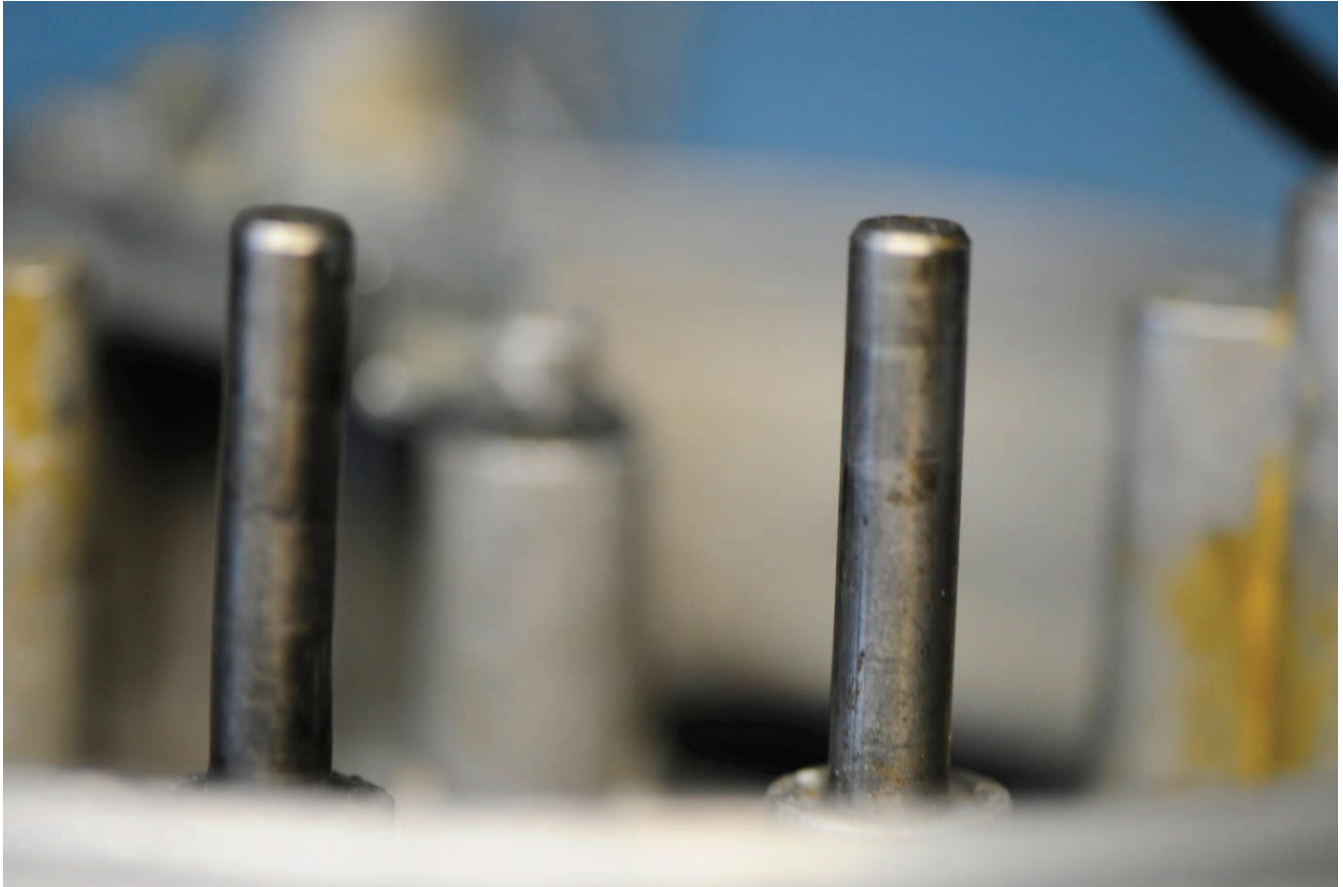
Take a close look at the gear shaft on the left. Notice it? Yes, it's bent and shows signs of uneven wear. This take a lot of force. Force from an uneven or over weight load. Most Hams pay attention to the static loads, but few take into account the enourmous loads placed on a rotor in windy conditions – or don't bother "balancing" all their antennas or arrays.

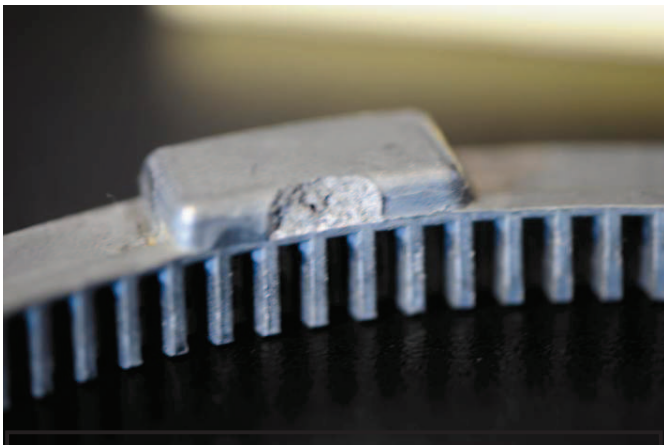
See the pressure points in the bearing track in the photo to the right? That is caused by wind pressure on a 10 foot mast and large HF yagi being blown upon by a 50Kph wind, causing up to 2000 pounds of compression on the poor little bearings. And no, the thrust or mast bearing doesn't carry all the weight, just the static load or dead weight.

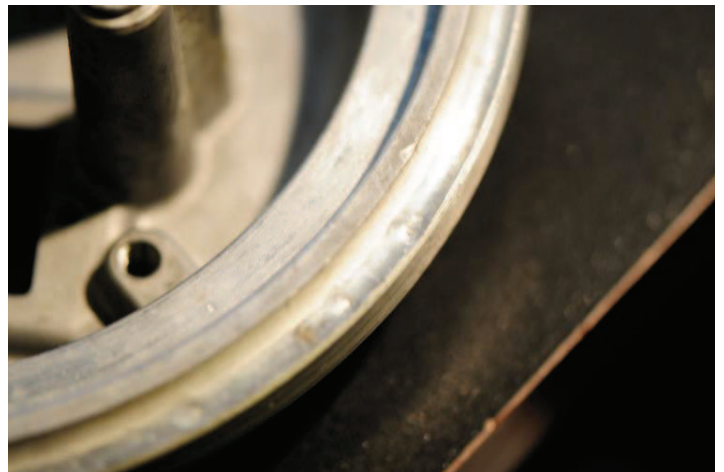
Notice what's missing? That's right, the cast tab on the ring gear – the one that hits the motor stop at each end of the rotation, is broken off...so the rotor doesn't know when to stop and keeps trying to turn....and the gearing ratio is such that it will keep trying until it breaks off more bits, burns out a resistor or two and maybe the motor winding – all just before the fuse blows...if it hasn't been replaced with a

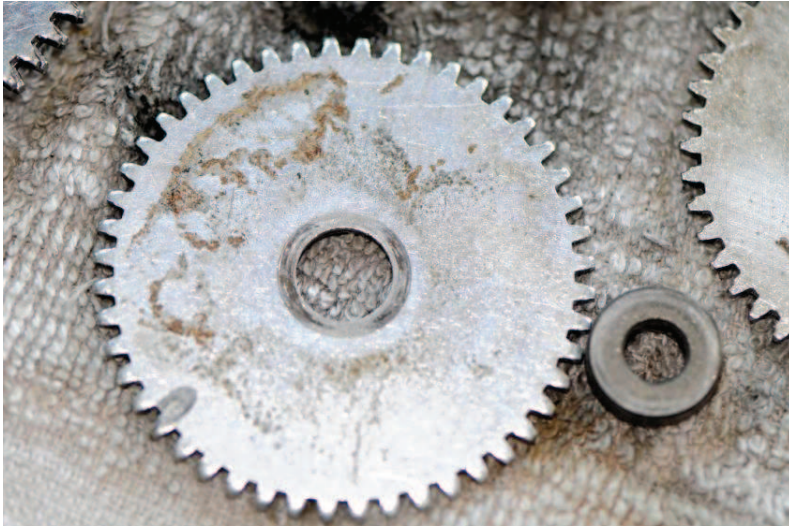
Filling the 1mm gap between gears – just because they might rub – does nothing but eat away at the protective coating on the gears and expose the metal to oxidation. It adds to the motor's work load, especially if it becomes less viscous when it's cold or contaminated with moisture. And grease does not "seep" under things to lubricate...thus the wear under the washer...

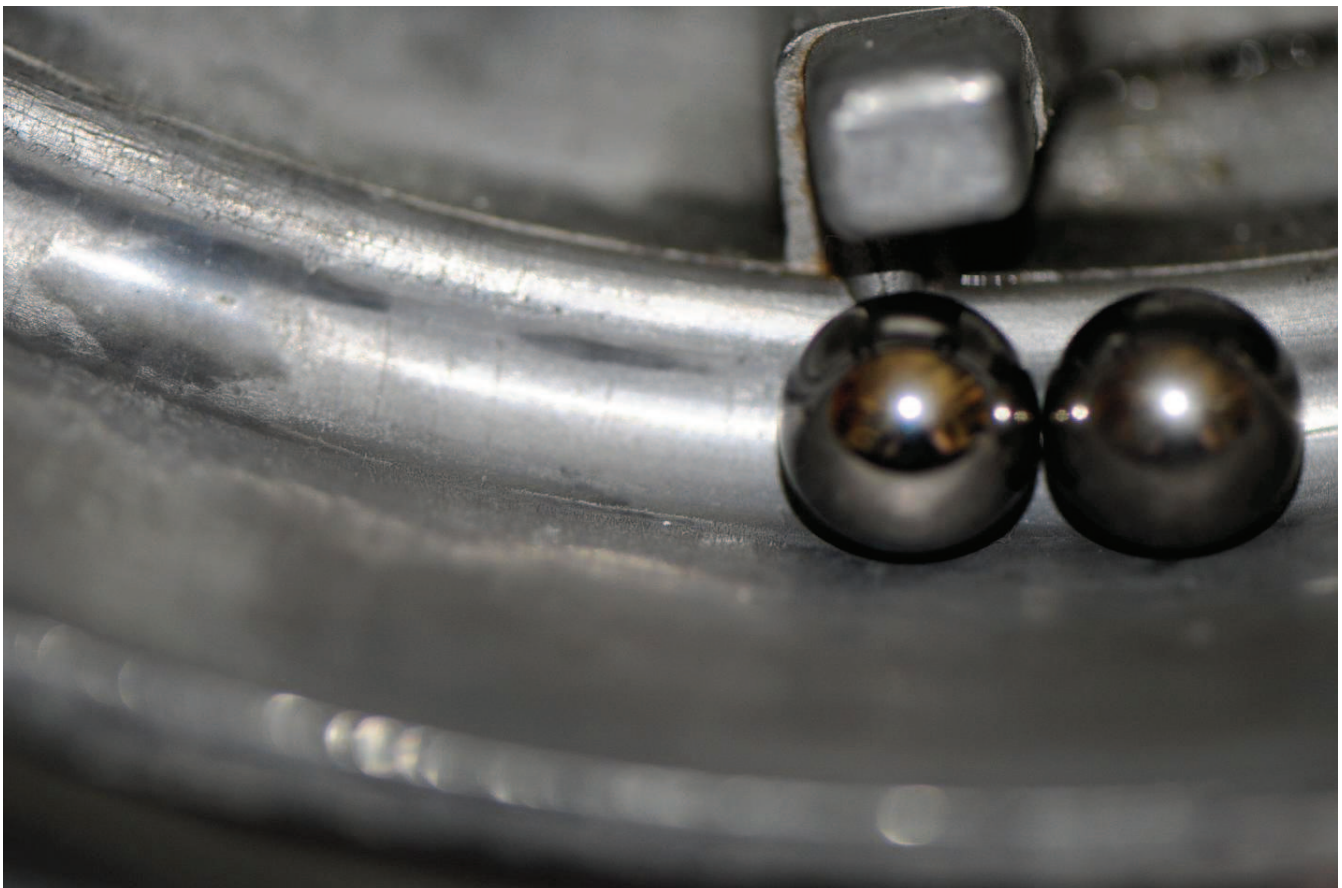
Notice the track wear and the bearing discolouration of the bearing on the right. This is caused by using the wrong grease, or too much grease, and too heavy a load on the bearings. Some grease will eat away at the coating of the bearing, causing it to lose it's shape and ability to roll smoothly. It rubs on the bearing track, causing abbrasions which in turn cause further bearing damage and the cycle continues until the bearing seizes. If the wrong grease is used, it solidifies with temperature extremes or when contaminated with enough water and the whole rotor starts a destructive cycle..

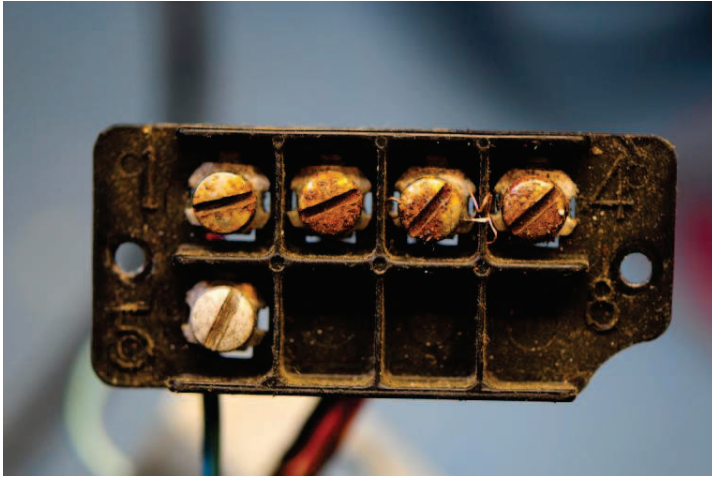
This is a rotor terminal strip which was coated with layer of silicone of some sort. Not too bad for something that has been up a pole for 15 years....but it still got wet, the connections still failed and the wire turned green with oxidation – because of water wicking its way down the cable... Had he applied an annual coat of a spray lacquer or plastic coating, it probably would have lasted longer in our great wet coast weather. Spraying is faster, easier and does get into places a thicker, less fluid silicone may not. Clear UV outdoor FlecoVarathene® does a nice job.
